# Vannoy-Blackburn Farm and Historic Preservation 12/3/10

By Trent Margrif, Cultural Resource & Outreach Specialist, College of Arts & Sciences,  
APPALACHIAN STATE UNIVERSITY

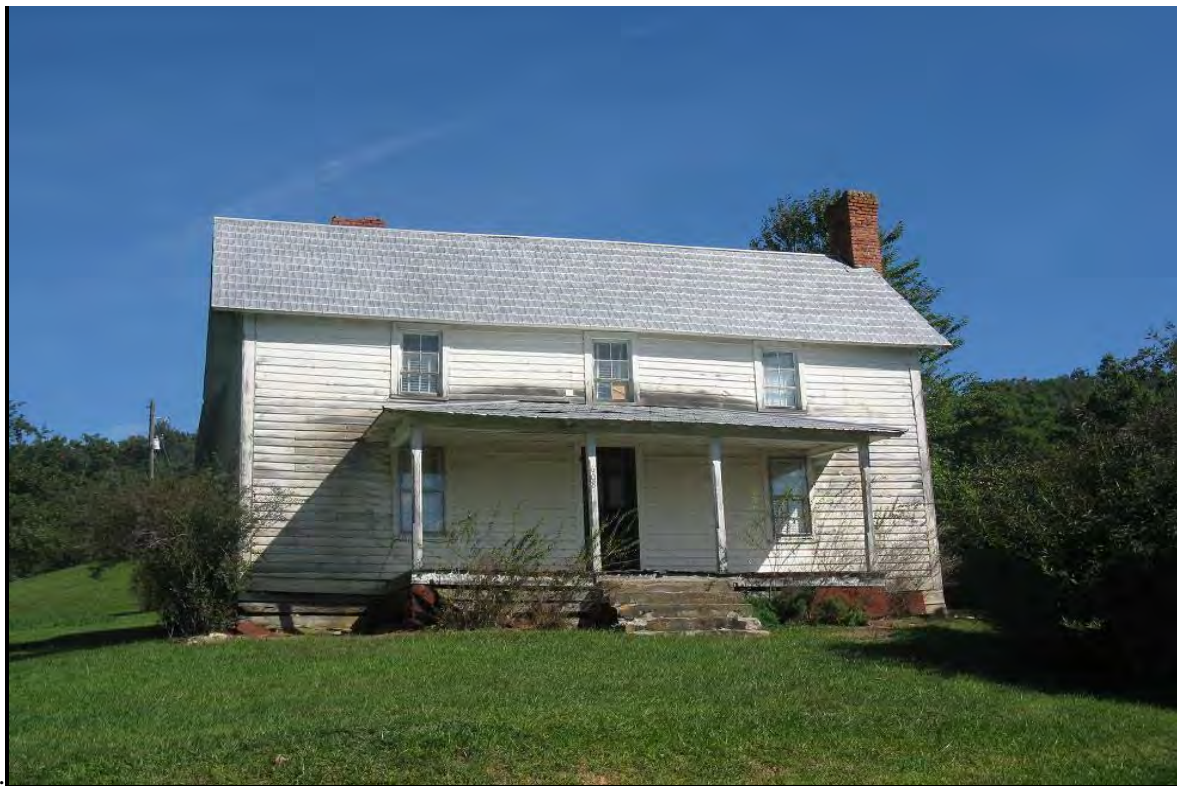
EXISTING CONDITIONS & PRESERVATION RECCOMENDATIONS – This structure is in generally good condition. Visual survey of the exterior reveals that much of the original fabric of the building is intact and operable. **Of primary concern is the structural stability of the current foundation, a structural engineer would need to verify the condition and stability of this foundation.** It does not appear that the root systems and branches of small trees and shrubs growing around and into this foundation have significantly comprised its effectiveness, but they should be carefully removed before they continue to grow further in this pattern. There are significant open spaces between the foundation and the frame of the house and evidence of past patch work fixes done with brick and wood that likely are no longer effective. These areas represent a crawl space that may be allowing significant rodents underneath the house, yet these large open spaces probably have also helped lower excessive moisture, rising damp, rising from the ground underneath the house. If a new foundation is required, making sure it has vents will help continue this desirable condition. There is some evidence that a “potato hole” may have existed around the building’s foundation as well. Typically six feet in diameter, and three to four feet deep used for storage in the cool ground around a farmhouse foundation. The areas where the porches attach to the main house frame are of the greatest concern and the front porch clearly is leaning downwards. An assessment of the condition of the brick chimneys, especially the eastern one which appears slightly slanting and detached from the central frame of the house at higher elevations, is also recommended. Handmade brick for use in the chimney was indicated in one past report; it appears much of this original brick material is still a component of this chimney.

A sculpted metal roof was placed on the structure likely in the past eight years; this has made a significant improvement in correcting evidence of previous water infiltration on the 2<sup>nd</sup> floor. Likely there was a metal roof previously on the property from the 1930s or 1940s, which replaced an original wood shingle roof, most likely of chestnut shingles that had deteriorated. An appraisal from 2/15/02 simply indicates a “worn roof” on this structure, prior to this replacement. This building did not have any noticeable gutters and some ground indentations on the façade and front sides of the building would indicate a pooling of water during heavy rains. This is problematic for the health of the foundation of the structure. Extended rooflines of the porch and the steep slant of the main roof assist with water distribution, but it likely is not exiting far enough away from the foundation. **Adding a gutter system with downspouts, screens, and strainers to the building is an important weatherproofing measure to take.** Access to the attic interior and inspection of roof trusses would determine their stability and state of deterioration as well, but these were likely improved or replaced when the metal roof was placed on the building.

Current exterior wood siding exhibits normal signs of weather deterioration, with some areas appearing virtually unpainted due to water staining. The most recent coat of white paint may be anywhere between 40 to 80 years old, and paint analysis would need to be done to determine previous paint colors on the exterior. However, it appears the current wood siding may not be original and more likely dates to the 1920s. This would need further research in comparing with similar properties nearby, exterior materials, and dates of construction. Four-over-four double hung sash storm windows, double hung single pane windows, and primarily original window wood frames are found throughout exterior elevations. Minor repairs are needed to restore the wood siding, trim, windows sills and frames, and door surrounds; all of these wood elements should be scraped and repainted. Storm windows should be installed over the original windows, for those that do not already have these, to improve the thermal efficiency and to protect its original fabric. Wood eaves along the rooflines and plain wood post columns on the porch facade are simple decorative features and appear to be in generally good condition and should be retained. Wood door entrances likely are original or date from the 1920s, at least one door has slight decorative paneling. General exterior rehabilitation should use the broad dates of 1880 to 1925 for a time frame.

Interior walls and ceilings have various wallpaper patterns and styles used over several decades and some slight decorative interior wood detailing around windows and doorways. This interior woodwork is in very good condition on walls and ceilings, and duplication of relatively simple millwork and moldings should not be difficult. The interior stair railing has some additional wood design and detail on the posts and railings. Additional interiors have unpainted wood lath boards, and other sections of replacement wood paneling painted white. Most wallpaper is peeling, in some cases significantly. Electric service installed in the 1950s may have caused minor damage to interior walls. Wood floors are found throughout the house with the exception of the kitchen, likely original or replaced last in the 1920s. The 2<sup>nd</sup> floor back bedroom has a significant hole in its ceiling allowing access to the attic, however it did not appear that animal (raccoon) habitation was significant. An earlier report on the property, from an appraisal done on 2/15/02 indicated significant water penetration on the 2<sup>nd</sup> floor and an overall poor condition in this area. The current interior should be considered in generally good to fair condition.

accessible route from a designated parking space to the first floor of this farmhouse, and at least one interior room converted to an accessible bathroom. Testing for hazardous materials is likely to reveal some amount of lead paint, a complete hazardous material survey and analysis should be conducted for the whole site prior to any rehabilitation work.

Finally, installing HVAC systems also plays a significant factor in an estimated cost. If collections will be placed on the interior of this building requiring temperature and climate control, then an appropriate system would need to be researched and recommended. Whether a proposed museum or exhibit would have year round or primarily seasonal usage also factors into this decision. The property currently does not have air conditioning or heating controls, furnaces or a hot water heating system depends also primarily on anticipated use. University faculty or students could perform an energy efficiency or similar audit for this building and assess options and costs in this regard. The water pump in the rear of the building is operable; on the interior an upgraded system would likely be needed.

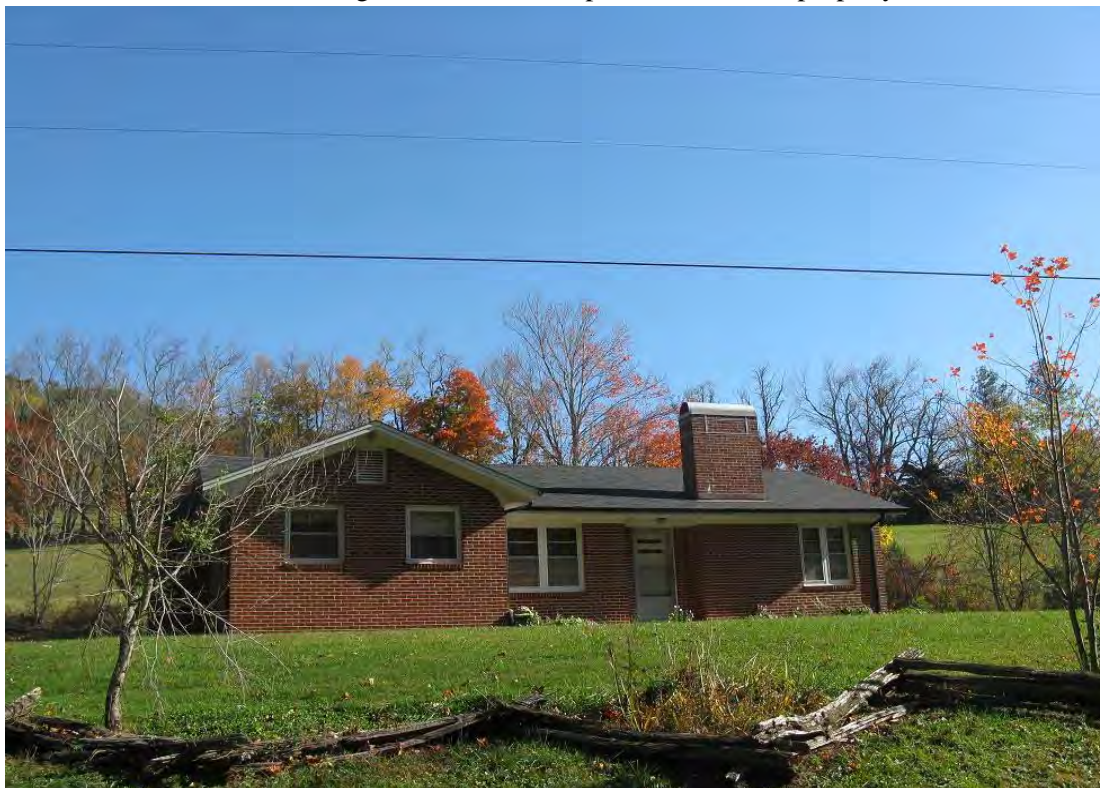
EXISTING CONDITIONS & PRESERVATION RECCOMENDATIONS- this property appears in good to excellent condition. Its recent occupancy has kept it in immediate habitable condition. Working heating/cooling, plumbing, water and electricity is confirmed; though all systems may require upgrades with increased and continual use of the building. The planned use for this building is to “house three to five sustainable development majors who will help manage the property.” With their future occupancy, additional maintenance issues can be observed and addressed, but this is not expected to be substantial. There did not appear to be evidence of mold on the interior, though with use as a student residence this should be explored further. There also may be code compliance issues to be addressed before occupancy. The building sits on a cement slab foundation with a slight crawl space and appears to have had a roof replacement of asphalt composite shingles within the last ten years, thus the main structural and moisture concerns have been addressed. Gutters and eaves appeared functioning and not clogged, though observation during rain should confirm this, and also whether the exit point for water is far enough from the building. Many gutters terminate underground and it is unclear whether they are draining efficiently, on the western elevation there are indentations in the ground indicating some pooling of water. There is some flaking of brick and paint on wooden window eaves and roof eaves. The central brick chimney has a metal bracing unit at its top portion in addition to flashing and it is unclear if this was a temporary or permanent measure for stabilization. The running bond brick veneer construction appears sound and doors and double hung storm windows functioning properly. This building would be classified as a non-contributing resource to a potential nomination of the site to the National Register of Historic Places; yet it does not detract from the larger cultural landscape values that the property holds.

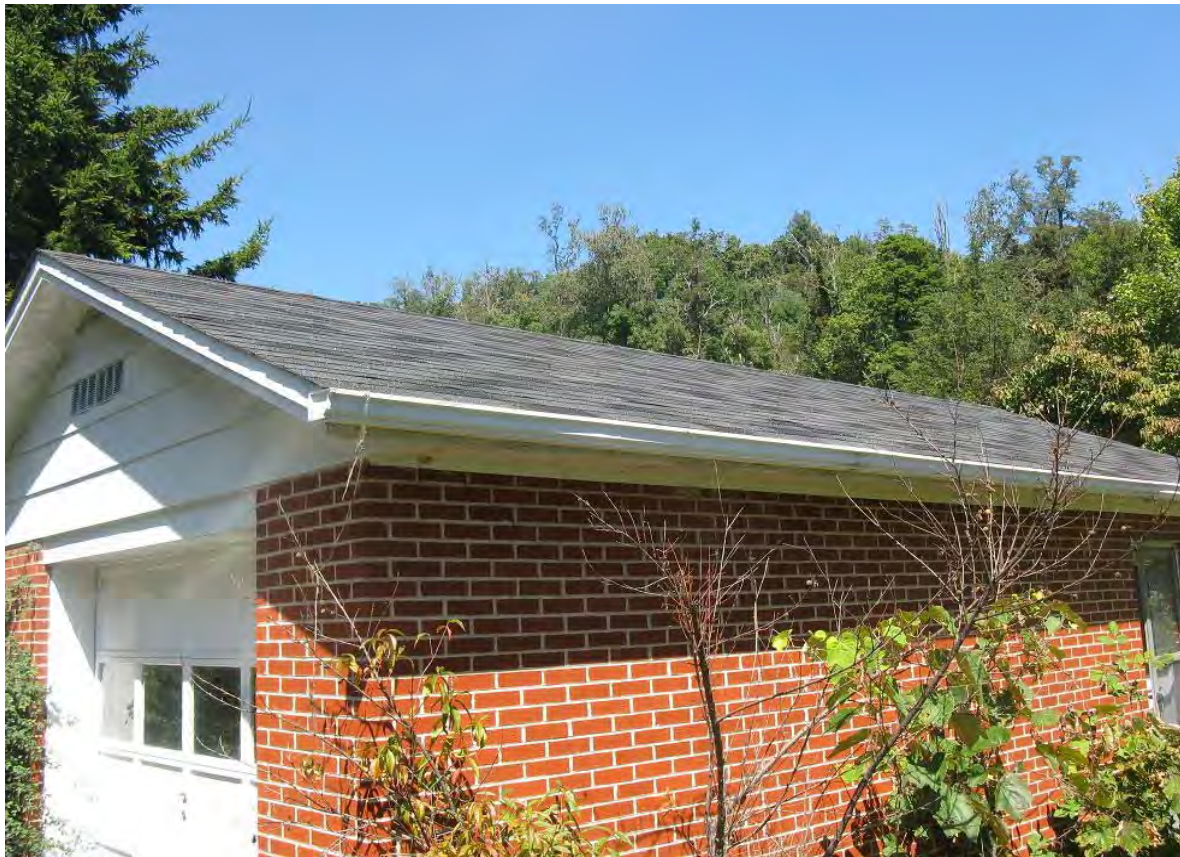
B.2 – garage – appears to have been built at the same time as the ranch house, likely in the early 1960s.

**EXISTING CONDITIONS & PRESERVATION RECOMMENDATIONS** – Brick is identical to the ranch house and similar composite asphalt shingle roof, gutters, and overall appearance. The four-paneled garage door with windows appeared operational, as did an additional door entrance. The two windows on the west elevation of the garage had white wooden trim and were operable. The building sits on a raised cement slab or concrete foundation. A significant amount of items are currently stored in the garage, including horse saddles. This building offers flexibility for its future use in storage, as a staging area, or a classroom and lab. There is currently no water, ventilation, or heating systems in the garage; an electric system is workable but the future use of the space will determine at what effective capacity. Vegetative growth surrounding the property is not significant, but should be removed in the rear elevation of the building at a minimum to prevent further concerns. This building also would not be considered as “historic”, but due to its size, scale, and location does not detract from the overall cultural landscape of this site. The J10 Jeep “farm truck” in front of the garage should be removed and does detract from cultural landscape values on the site. There are wooden fences, largely covered by existing vegetation, around two elevations of this building and the ranch house. These could likely be uncovered and highlighted to enhance the visual appeal of this section of the property.

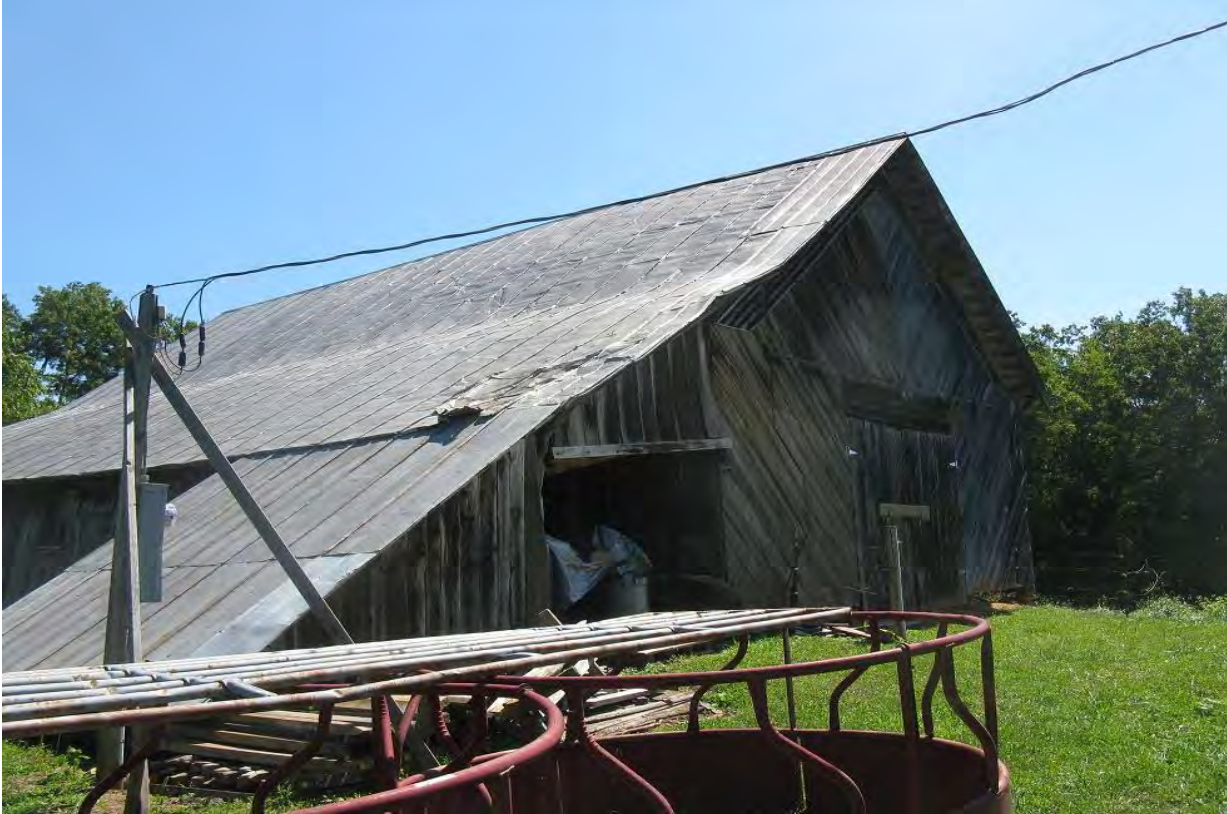
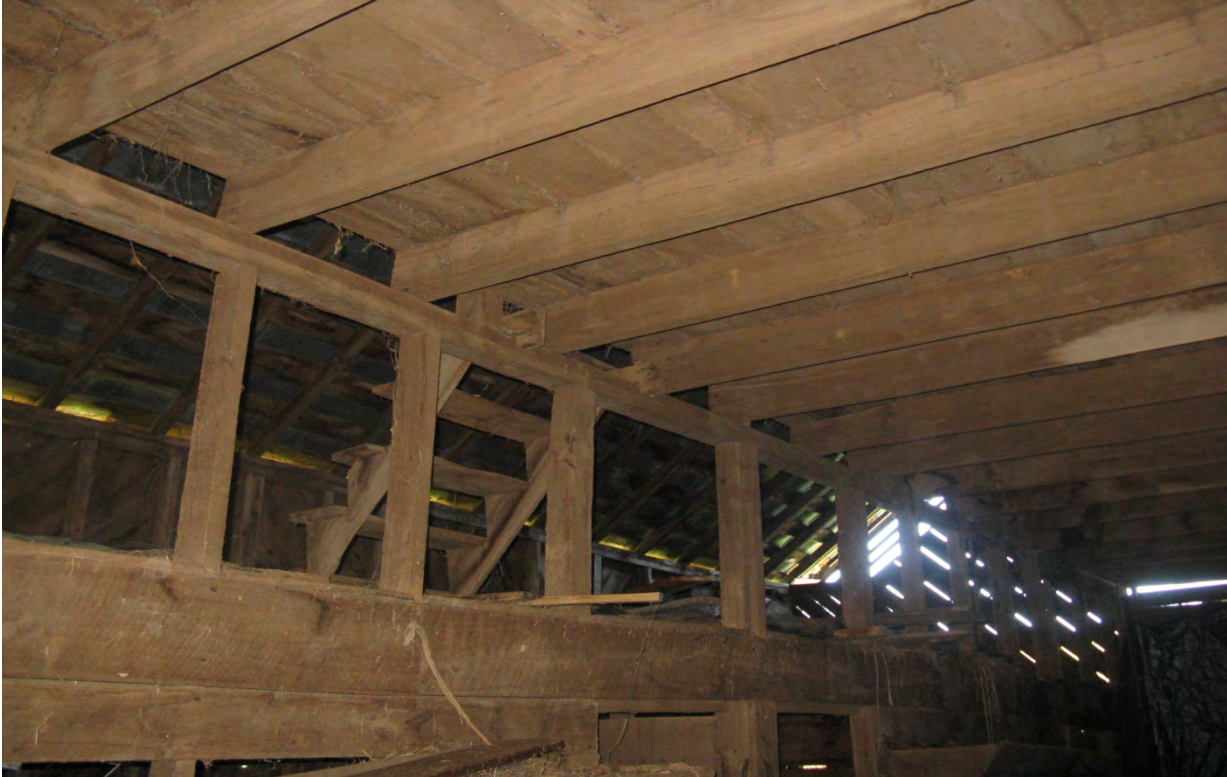
EXISTING CONDITIONS & PRESERVATION RECCOMENDATIONS – this frame structure has a central aisle and stalls on the ground floor, hayloft above, and side sheds. The utilitarian side-gabled with elongated shed roof building is primarily constructed of unpainted weatherboard with some replacement portions of more recent wood panels. The central barn bay door is on rollers, and this feature should be maintained. A portion of the north-facing roof had a fragment of original chestnut-shake roofing; this may still exist under the sculpted metal sheet panels that currently serve as the roof and were likely placed on the structure and on top of portions of the original roof within the last eight years. A report from the early 2000s indicates this structure is “too deteriorated for salvage or repair.” The current condition appears to be poor to fair, but not “beyond repair.” Stabilization is important in barn structures, especially ones actively used. The side and rear exterior walls do not appear heavily slanting, but with original wood construction a structural engineer should assess this current condition. The front sloping wall and roof however have a noticeable slant; this may be due to the storage of hay and an added weight load on the 2<sup>nd</sup> floor of the interior in this portion. A structural engineer would need to determine whether a new foundation is needed, or if sills and plates need to be repaired or replaced. Often the whole exteriors of barns are tied with cables to hold into the structural system securely. There also is a temporary tarp covering a portion of this roof, which is a temporary solution to the larger need of a stronger metal roof portion in this area. Rainwater is probably draining effectively from this roof, but due to past roof ineffectiveness the interior portions of the barn are more deteriorated in this northern portion. An assessment of the roof’s wooden framing system including joists, beams, braces, posts, rafters, and trusses is also warranted; though this deterioration appears to be minimal. Barns make no effort to conceal their structural systems due to their utilitarian purpose, and this example is no exception. Wholesale replacement of the historic structural system with a different system should be avoided unless deemed necessary by a structural engineer. There is no evidence of a powder post beetle, ant, termite, or similar insect infestation. Past easement language indicated this barn should be “immediately” stabilized, some amount of stabilization has taken place in the past eight years, likely when the roof was replaced, on the structure. If this barn is intended to be used in the future for livestock then greater steps should be taken for its further stabilization. The existing exterior and interior features of the structure can easily be retained; most wooden partitions, stalls, and storage bins appeared in good condition. Electric service is currently operable in the barn and a utility pole with meter is found near the northern façade of the building. No heating or ventilation systems were observed in the barn. Wire fencing is found around the rear elevation of this building and should be removed, unless it will serve a future livestock holding purpose. In future use, soil and manure buildups against the foundation should be removed, as they hold water and snow against wood and promote rot and insects. Given this structure sits on the highest

elevation in this tract, adding a lightning rod is also warranted. Due to the size and potential fragility of the roof, electric heating tapes and snow guards might also be considered on this and other outbuildings.

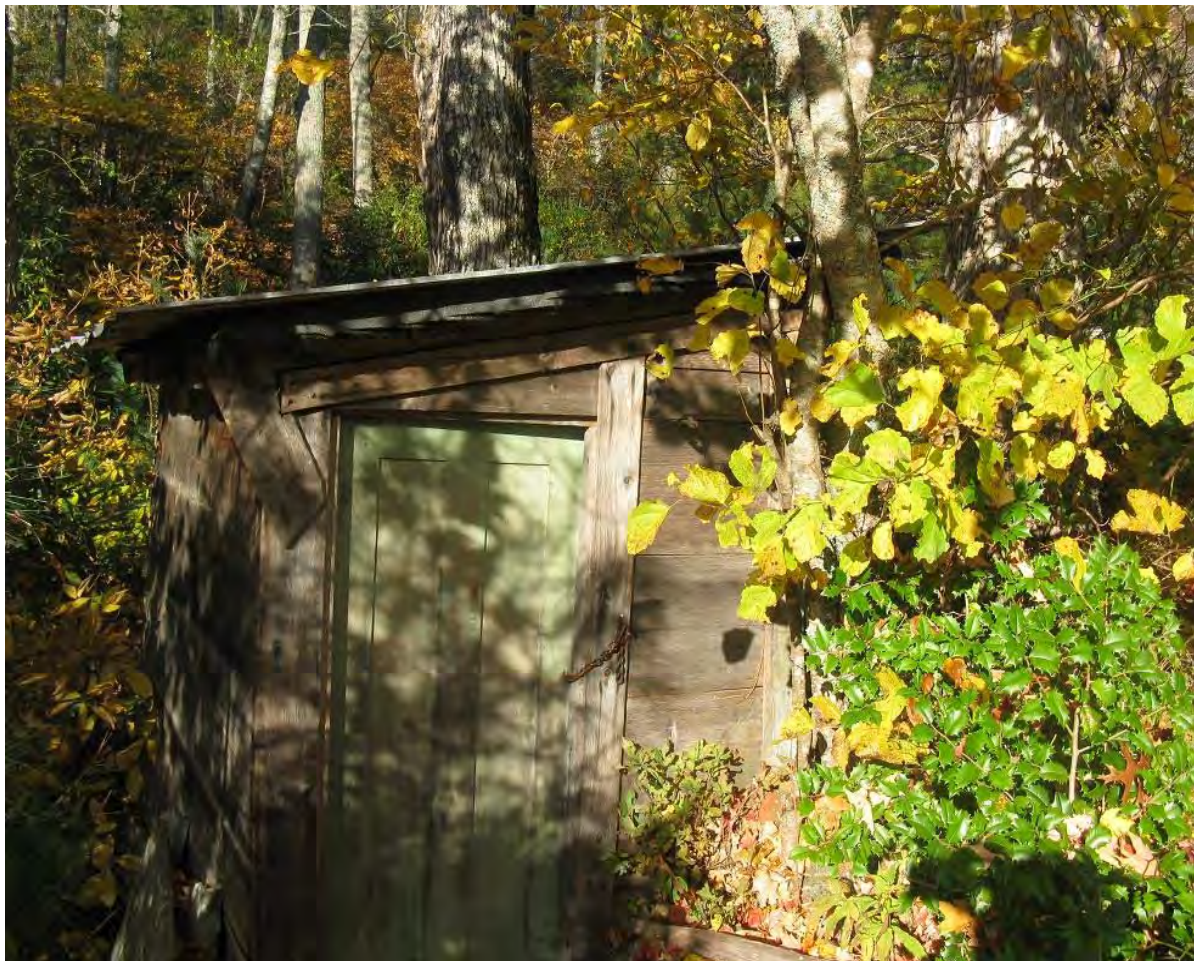
EXISTING CONDITIONS & PRESERVATION RECCOMENDATIONS – past easement language indicates this building should be “immediately” stabilized, but its current condition does not warrant such action. Upon visible inspection it appears structurally sound and could continue to be used for storage, and possibly an active use for agricultural storage. There is a metal pipe underneath and adjacent to the springhouse where water flows from the creek beside it. The fluctuation of this water level determines whether there is an additional threat to this property and its foundation and lower level, but this does not seem likely. This building should be retained and utilized in its current location, and would be a contributing resource to a potential National Register listing for this site. A pile of cinder blocks and wood tree blocks near this building could be utilized at other areas on site or stored for future use.

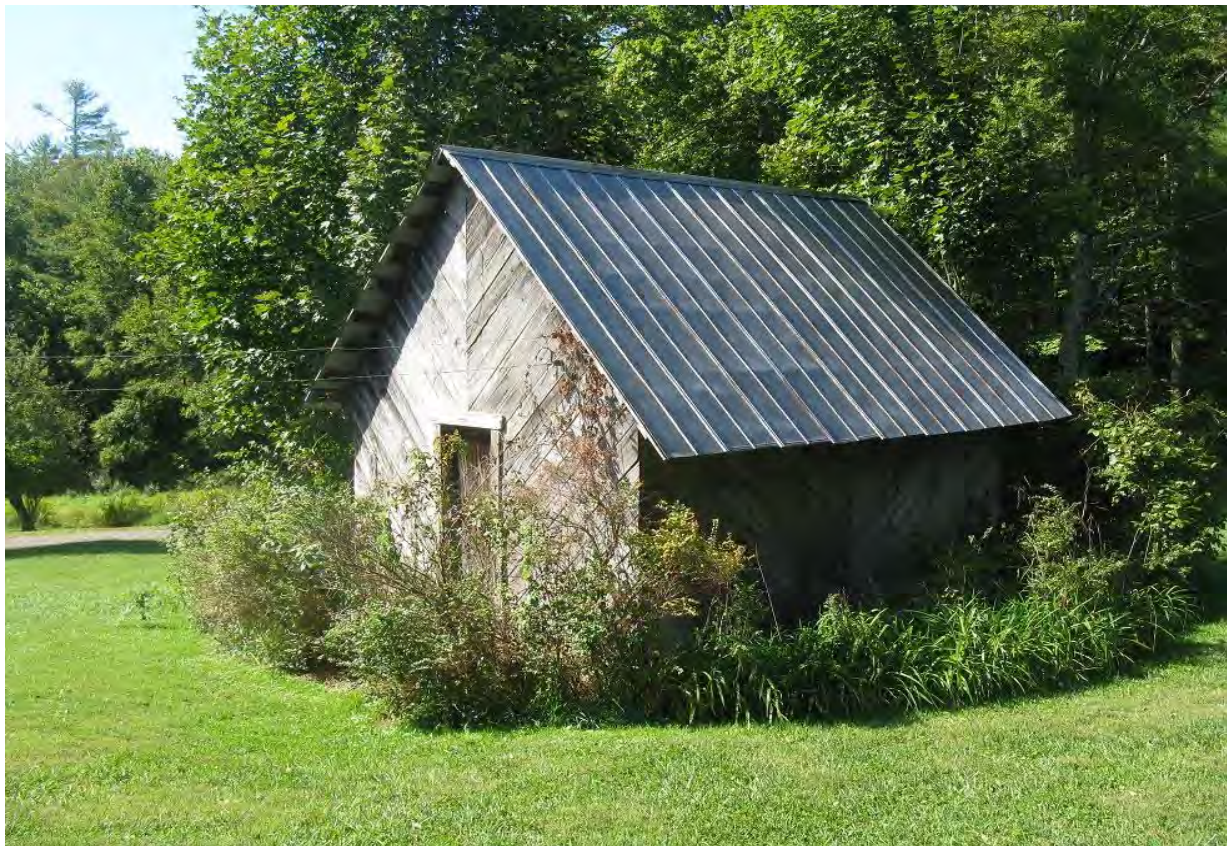
**EXISTING CONDITIONS & PRESERVATION RECCOMENDATIONS** – in generally good condition, the slight amount of brush and vegetative growth around the base of the building should be cleared entirely. There is at least one tree that rises above the roofline of this building and whose branches and roots may have an impact on the future structural stability of the building, as these branches are also found growing within the interior. This would need to be confirmed and a decision made on its removal or not. The wooden boards are arranged in a pattern similar to the Large Barn and its construction likely is around the same time, the newer roof of sheet metal attached to original wood eaves is also similar to the Large Barn. It is a smaller structure so stabilization is less of a concern, and it could serve for grain storage or other agricultural storage purposes. The current interior has a small amount of agricultural equipment and materials, including those which may be considered hazardous and these should be disposed of properly. There is a 2<sup>nd</sup> floor level on the interior of wood and the weight load and capacity of this level would need to be tested before additional storage use. Utility wiring connects the granary with the Blackburn farmhouse and there may be an active light switch in the interior.

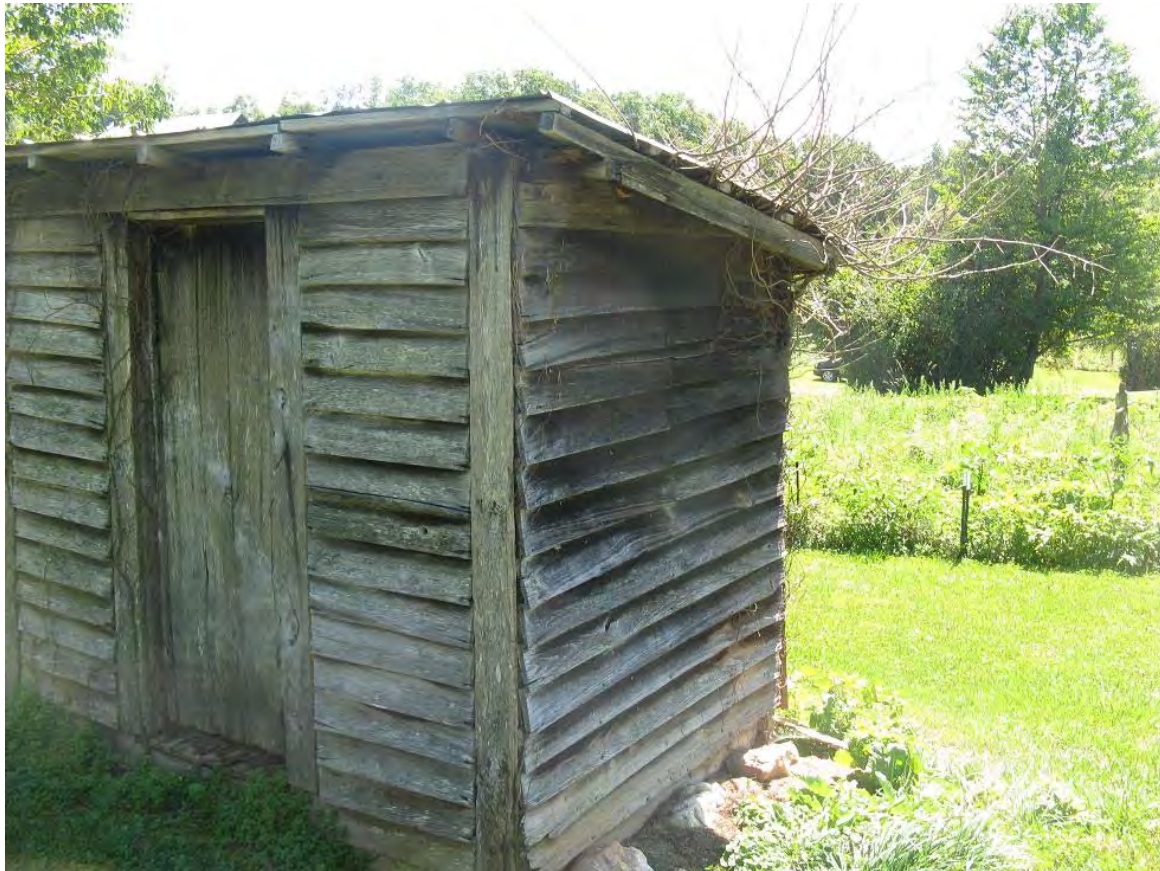
E.2 – outhouse – dating from early 20<sup>th</sup> century likely, may have been disassembled and reconstructed from nearby site in past 100 years.

EXISTING CONDITIONS & PRESERVATION RECOMMENDATIONS - in generally good exterior condition, it appears to have been moved from a previous adjacent location as is typical for outhouse buildings. The amount of small tree branch growth on the rear elevation is minimal, and this can likely be broken off and removed without damaging the exterior. This structure could be used for living history interpretative purposes. There are a few historic sites that utilize their outhouses as working bathrooms for authenticity, but this is not recommended. The shed roof and horizontal wood construction is common for this building type.

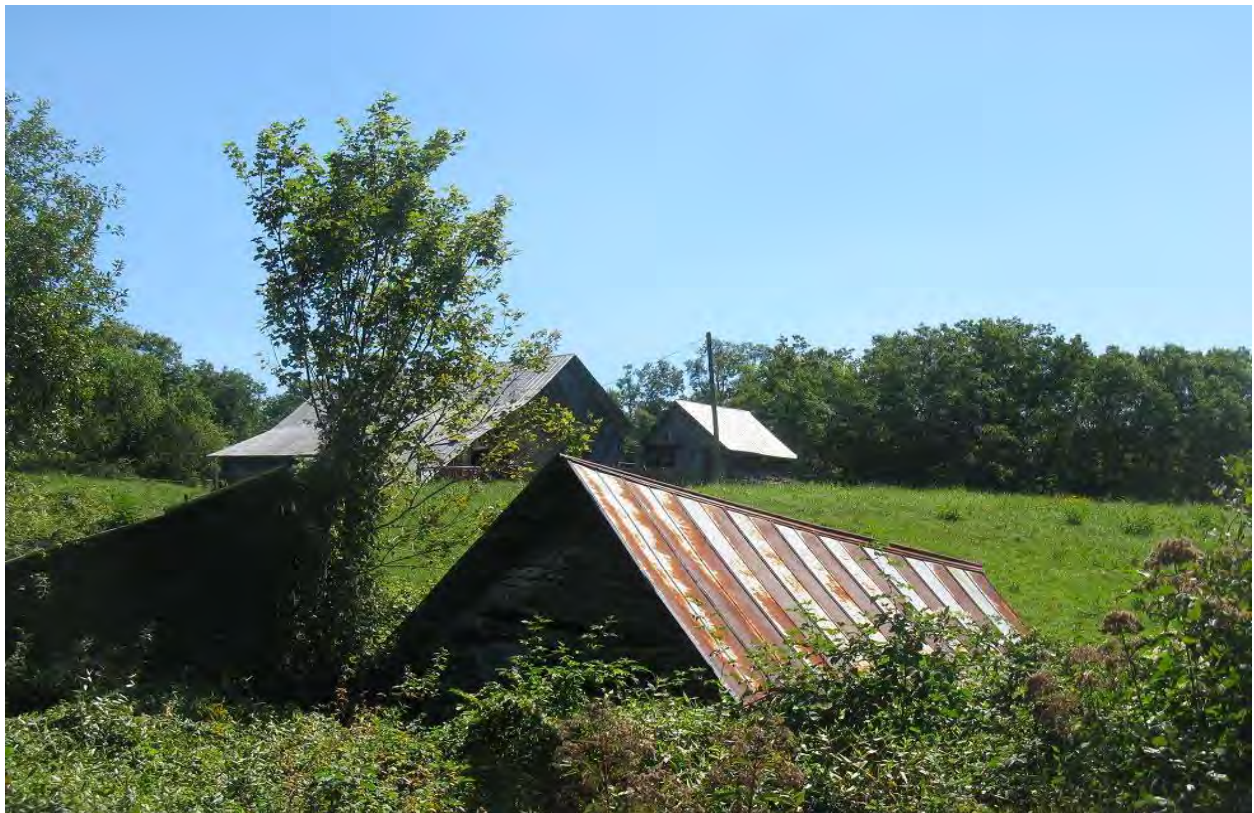
E.3 – chicken coop – likely dating from the early 20<sup>th</sup> century, best guess at its historic use also referred to as a “chicken house”.

EXISTING CONDITIONS & PRESERVATION RECCOMENDATIONS – the building is significantly deteriorated and in poor condition. Thick brush reaches the roofline on this structure and may have compromised its base and wood construction. After this vegetation is removed, a further visual inspection would be needed and likely the building could be used for storage after strong stabilization efforts. There is some collapse of upper floor boards, but deconstruction should be considered only for liability or safety reasons. In this scenario, the wood could be reused in other buildings on site. The metal roof on this building has not been recently replaced, unlike other outbuildings on site. This outbuilding, even in its current condition, would be considered a contributing resource to a National Register listing and the cultural landscape. Removal may be necessary once vegetation is removed, but only if it is determined structurally unsound.

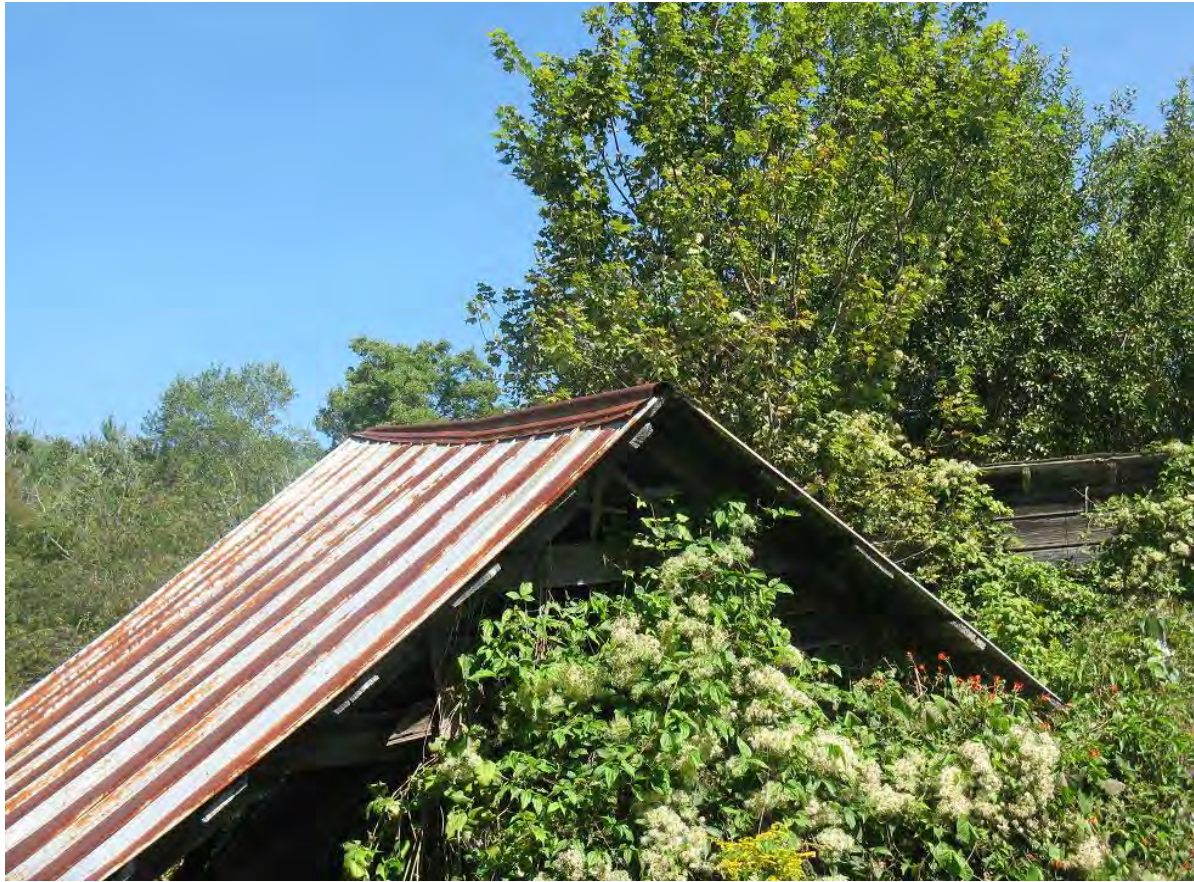
E .4 – pig barn – likely dating to the early 20<sup>th</sup> century, this is an educated guess at its historic use, may also be known as a “hog house” or “hog barn.”

EXISTING CONDITIONS & PRESERVATION RECCOMENDATIONS – in a deteriorating and poor condition. Thick brush reaches the roofline and some upper floor boards appear to be in a state of collapse. This structure could be deconstructed and the wood material reused, or allowed to remain in place for storage of material that does not need to be strongly secure. The metal roof has not been recently replaced like other outbuildings. This outbuilding, even in its current condition, would be considered a contributing resource to a National Register listing and the cultural landscape. However, its removal may be necessary once vegetation is removed and it is determined structurally unsound.

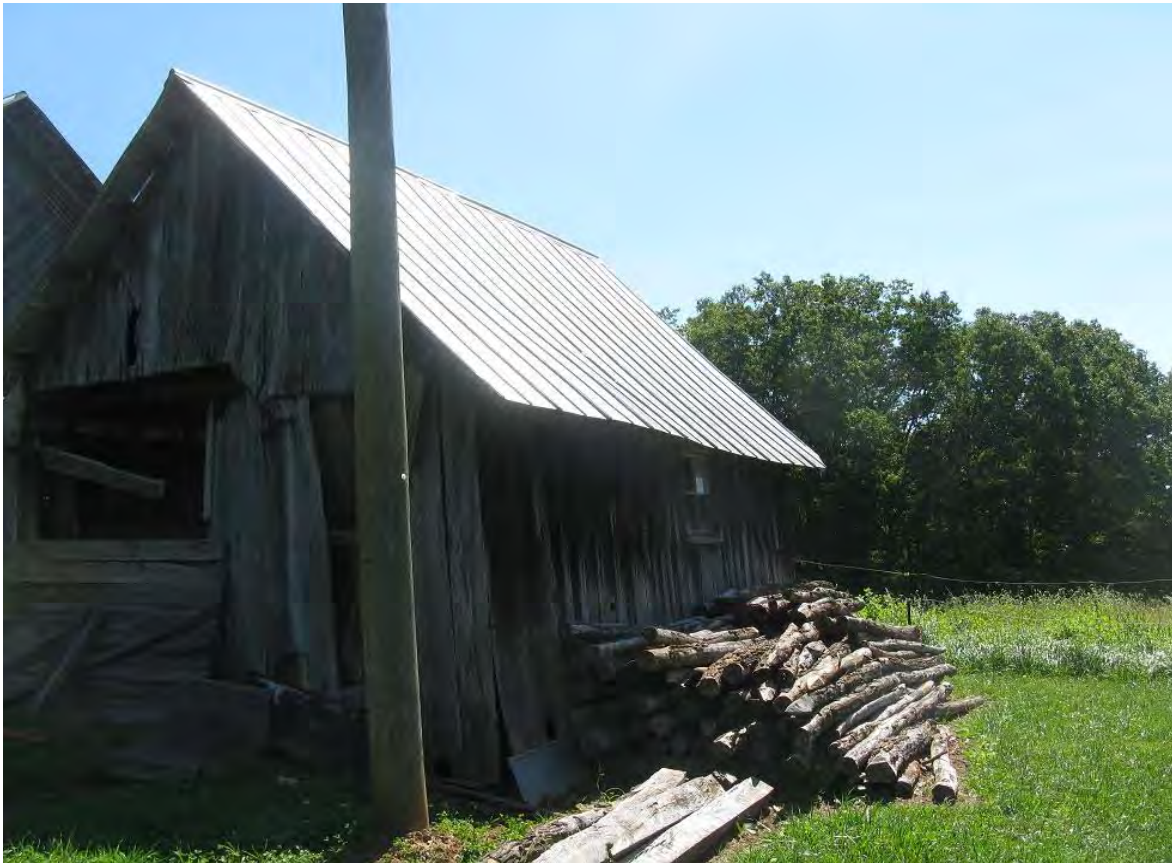
E.5 - wagon shed – likely dating to the early 20<sup>th</sup> century. Use is determined by current storage of wooden wagon and wagon wheels on its interior.

EXISTING CONDITIONS & PRESERVATION RECCOMENDATIONS – smaller frame structure in fair condition. It has a newer metal roof, replaced likely at the same time as the barn. The items that currently exist in the interior could remain for interpretative purposes or be removed for this building to be used for storage adjacent to the barn. There appears to be a slight slant on the eastern facing exterior wall, but overall the building appears stabilized. The open window bay on the northern elevation may also indicate a horse was housed here in the past. The wooden boards are set vertically without the similar detail found on the Large Barn. Wire fencing is found around much of this building and should be removed, unless it will serve as a future livestock pen.

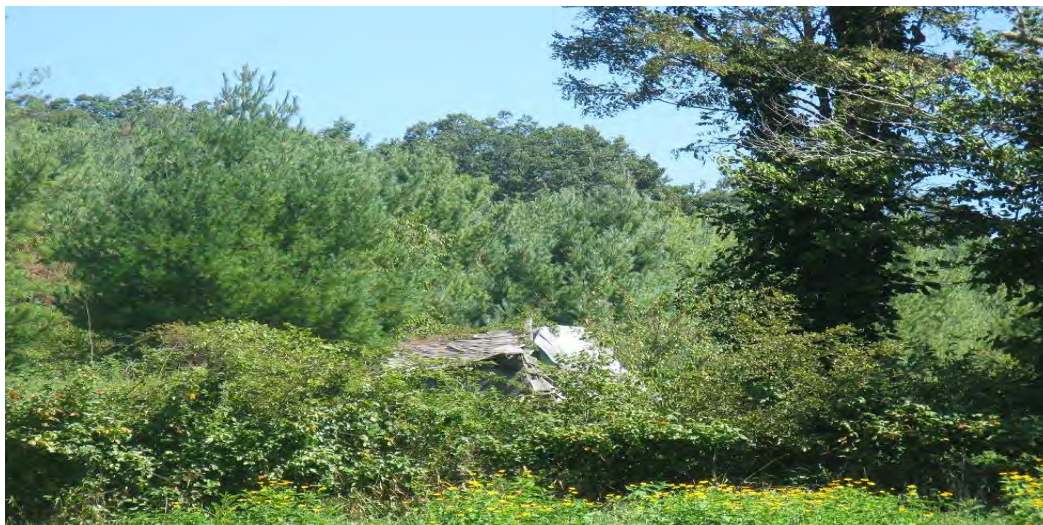
E.6 – Barn Ruins - collapsed outbuilding away from central site, believed to be a former smaller barn structure, maybe this was used for sheep. Likely constructed in the early 1900s.

EXISTING CONDITIONS & PRESERVATION RECCOMENDATIONS – for liability and safety reasons this structure should be further collapsed and the material reused on site. While worn down structures on the landscape are part of the cultural history and importance of a site, this building is further removed from the other outbuildings and has reached a state of being “too far gone.” Easement language indicates “all collapsed buildings and old fences should be removed.” Exhibit C in the easement also noted “four existing barns on site, including one already collapsed”; it is assumed the document was referring to this structure. With considerable effort the walls could be returned and a new roof placed on the building, but only if a use is determined. The barbed wire fencing on the property if serving a future purpose could be retained; there also exists wood fencing in some portions which should remain.

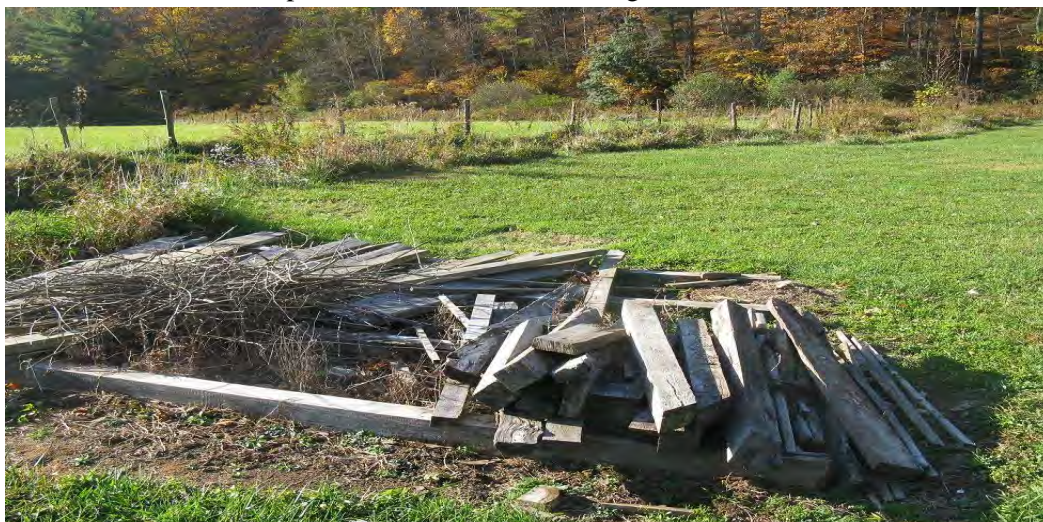
E.7 Collapsed Wood Materials – unable to determine whether these wooden boards were part of an existing building on site or recently dissembled. It appears they are on top of a small garden plot, and these materials can be reused on site and stored in the storage shed if replacement wood materials are needed for immediate repairs to additional outbuildings in the future.

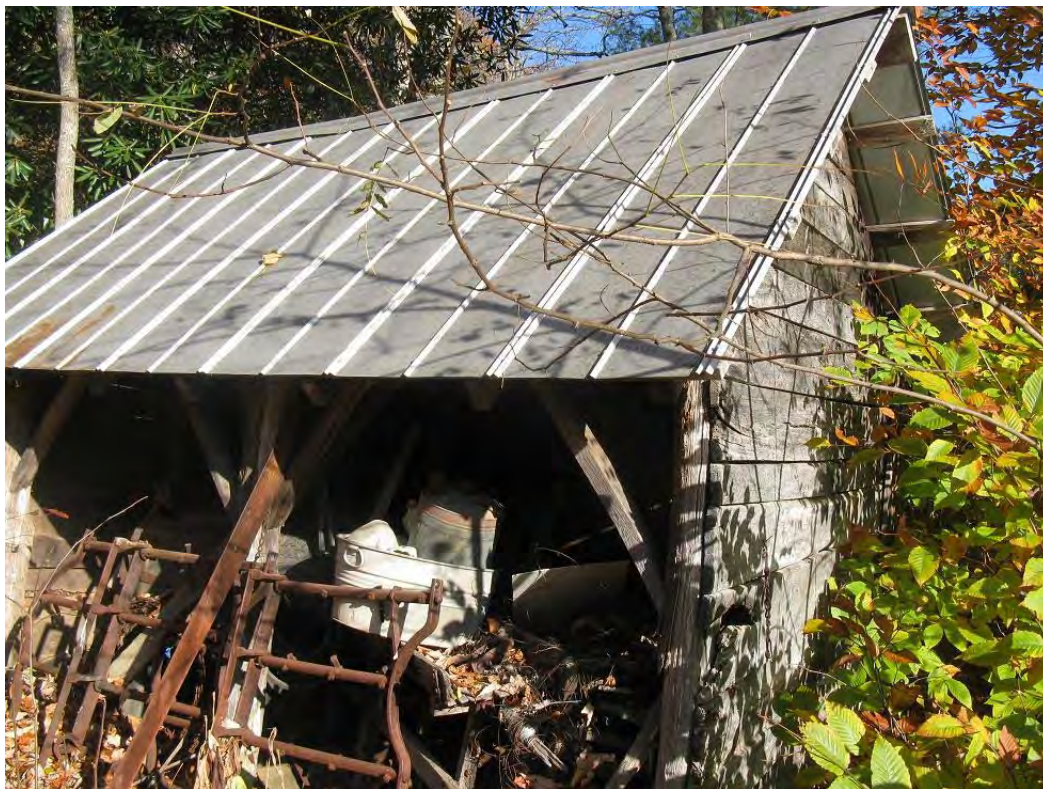
E.8 Storage Shed – likely dating to the early 20<sup>th</sup> century, this building has had a replacement metal roof attached to its wood eaves likely in the 1960s. Most likely was used historically as a wood shed.

EXISTING CONDITIONS & PRESERVATION RECCOMENDATIONS – the horizontal weatherboard planks appear in fair to good condition. The building’s southern elevation is an open bay that currently houses agricultural equipment and metal containers. This property can be left in its current condition and location and utilized for storage. The open bay can be covered with a tarp or similar temporary storage measure for protection of stored items. The building currently stores agricultural equipment and containers, and what would appear to be an upper millstone with traditional deep grooving. It would not be unusual to suppose a small grain milling operation took place on site, in the nearby granary building.

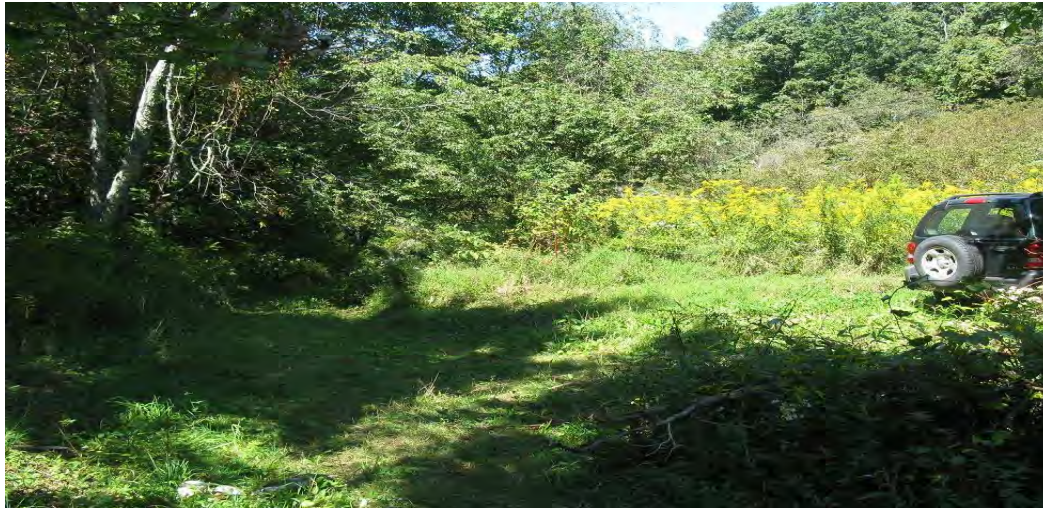
F – roads & trails – primarily dirt and gravel trails exist on the property; most may date to the logging operations on the property from the 1940s to the 1960s.

EXISTING CONDITIONS & PRESERVATION RECCOMENDATIONS – An assessment of existing roads and trails should take place after the new entrance road is implemented. Also gauging an estimate on the amount of projected use on existing roads and their conditions to help determine preservation efforts if any. Roads & trails are also considered cultural landscape features as part of the site’s history.

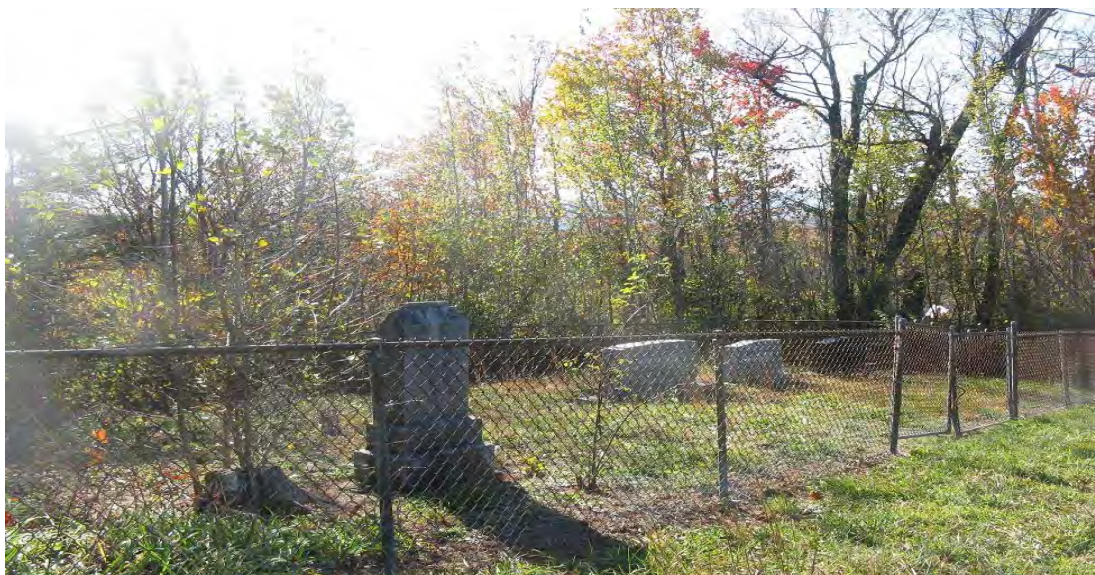
G – cemetery – this roughly 60 foot by 10 foot plot of land has a dozen headstone and grave markers specific to the Vannoy and Blackburn families. Most prominent are the most recent modern headstones that say “Vannoy” and “Blackburn.” It is surrounded by a modern chain link fence with locked gate.

EXISTING CONDITIONS & PRESERVATION RECCOMENDATIONS – the current vegetative growth does not have a major impact on the appearance and conditions of headstones. \$40,000 was set aside in a family will for the “upkeep and maintenance” of this family cemetery. The cemetery is a contributing historic resource to this site and should receive minimal to no alterations.

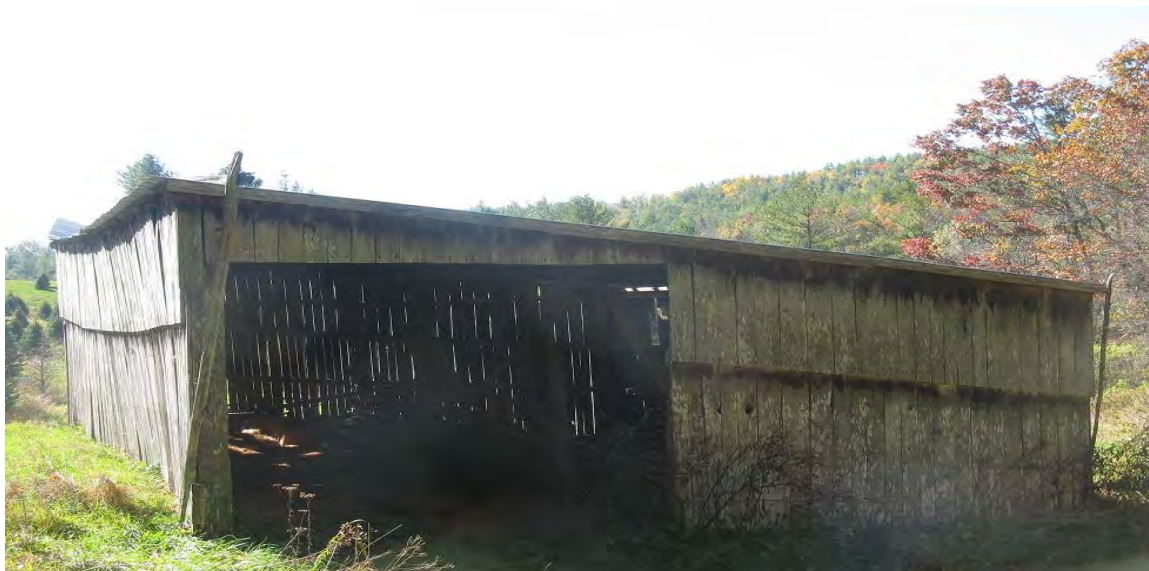
**EXISTING CONDITIONS & PRESERVATION RECCOMENDATIONS** – this smaller barn building has a slanted shed roof and open bay on its façade. It most likely was utilized for the storage of feed for livestock, as it is located on the edge of pasture. The wood paneling of the building is vertical and with slight spaces in between boards, which is unlike any other agricultural outbuilding on site. There is a noticeable slant in the roof and the more recent metal roof is unattached in some portions. The instability of this roof is contributing to the building's current structural issues and is overall in poor to fair condition. Stabilization of this property is recommended as it contributes to the cultural landscape of this site. Though currently surrounded by Christmas trees from the previous Christmas tree operation on this portion of the property, it is an integral building that highlights the transition between pasture to forest.
