# Vannoy-Blackburn Farm and Historic Preservation 12/3/10

By Trent Margrif, Cultural Resource & Outreach Specialist, College of Arts & Sciences,  
APPALACHIAN STATE UNIVERSITY

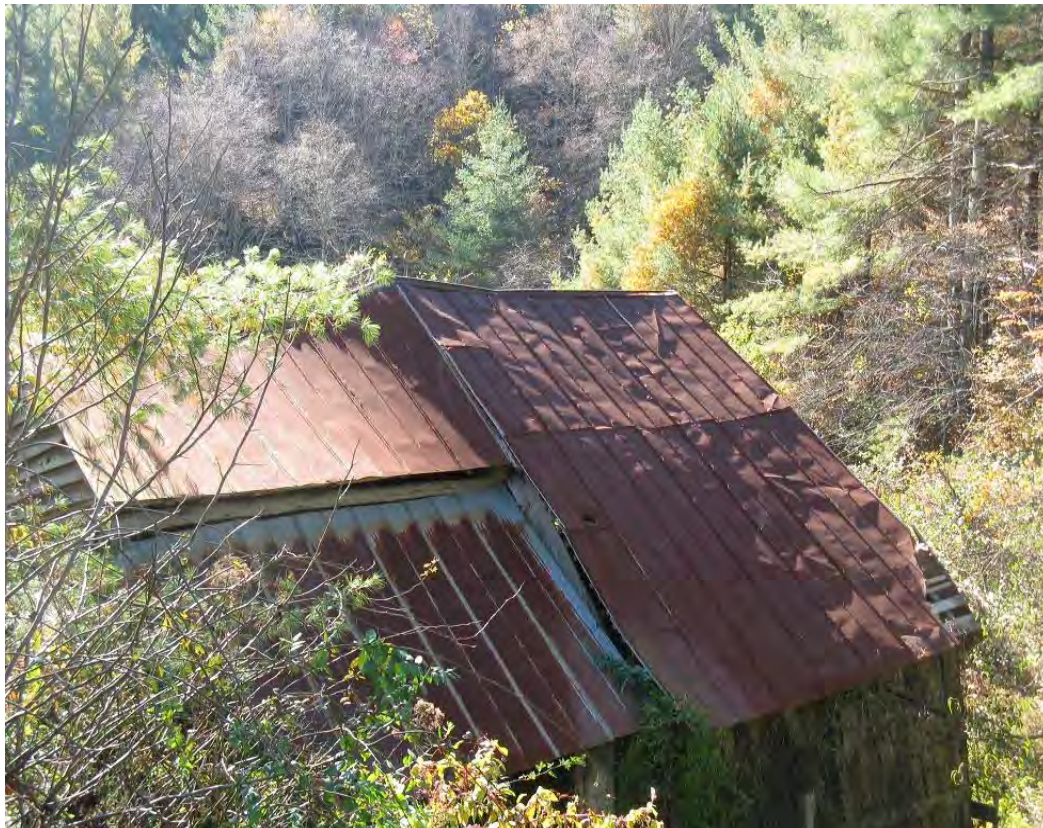
EXISTING CONDITIONS & PRESERVATION RECCOMENDATIONS – “the several farm structures are so dilapidated as to be worthless” is the language used in the easement. The current condition of this building would be considered poor and possibly is in imminent danger of collapse due to several factors. Most notably is the weight of either original or replacement metal roofs on the frame of the building, there also is a clear portion that is gone and now covered by asphalt strips and tattered strap coverings. Also significant is the amount of vegetative growth on the southern elevation of the building, which is potentially pulling this wall downward. If this building is to be used it is in need of immediate stabilization, any significant additional weight of snow and ice in the coming winter has the potential to collapse it. On the interior is original wood floorboards, brackets, and eaves; the exterior is primarily unpainted weatherboard in both horizontal and vertical patterns. The interior also contains agricultural supply items and equipment. The building has a definite slant in its current condition, and a structural engineer would be needed to determine how to correct this. However, unless a specific future use of this structure is determined these efforts may not be warranted and the building could be purposely collapsed for safety and liability reasons. This material can be utilized for future repairs on other outbuildings.

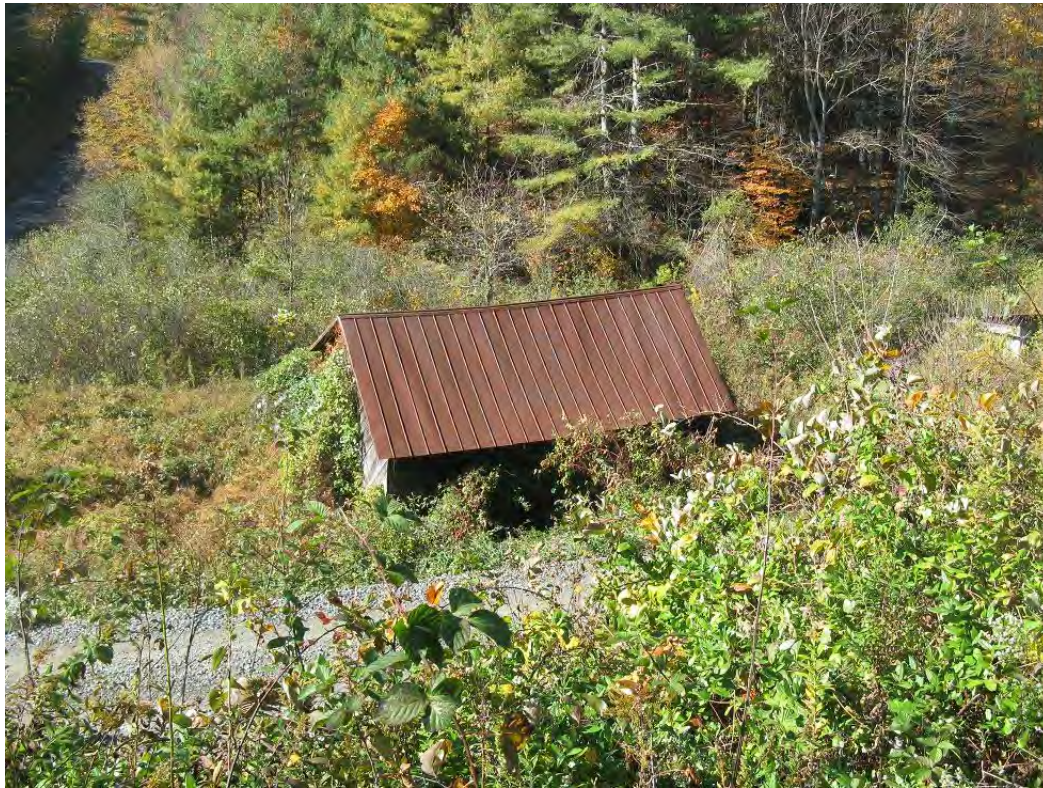
(ii.2) agricultural outbuildings – smaller barn – likely dates from the early 20<sup>th</sup> century.

EXISTING CONDITIONS & PRESERVATION RECCOMENDATIONS - “the several farm structures are so dilapidated as to be worthless” is the language used in the easement. This building is in fair to poor condition, but salvageable. The original or replacement metal roof on the structure appears balanced on the frame and not weighing down the structure. The unpainted weatherboard also appears in fair condition, as does interior wood floorboards and eaves. Vegetation surrounding the building is a significant problem, and should specifically be removed in its western elevation before this condition worsens. The current interior configuration indicates it was used to house animals, possibly a horse, and currently contains agricultural supplies and garbage. Continued use for storage is feasible in this structure, and it can likely be shore-up and stabilized easier than the larger barn structure nearby.

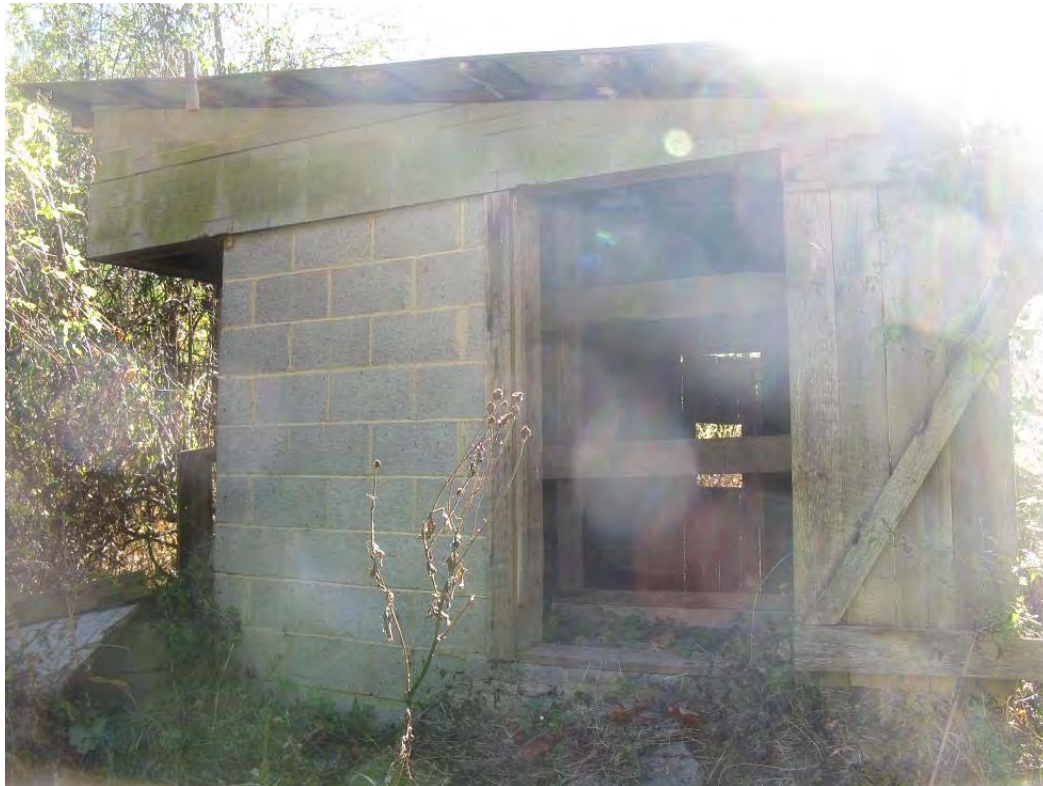
(ii.3) agricultural outbuildings – shelter - likely dates from the 1950s or 60s.

EXISTING CONDITIONS & PRESERVATION RECCOMENDATIONS - “the several farm structures are so dilapidated as to be worthless” is the language used in the easement. Unlike all other agricultural outbuildings, this structure is made of cinder, cement, or concrete block and not wood. It does have interior wood framing and a wooden shed roof with modern metal covering. It appears likely that this building would have initially had unpainted weatherboard on its exterior, but this was replaced by the more solid block material later. While this structure may not be considered historically significant, it is an existing building and should be retained in its current location. This lends to the impression of the site being a working farm and retaining at least a few of the outbuilding that used to exist on site, from various time periods. An original wooden door exists on the western elevation and the eastern elevation has an open entrance. The building could continue its use for storage, currently sheltering garbage and farm equipment, and likely of more sensitive or fragile materials given its sturdy construction.

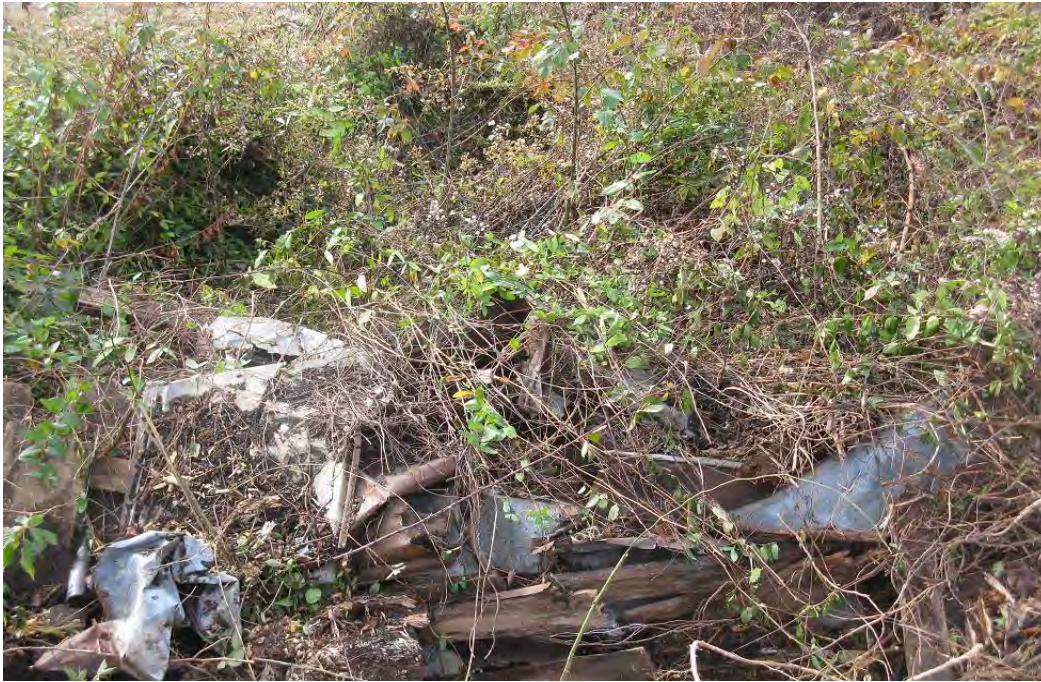
(ii.4) agricultural outbuildings – collapsed building – likely dates from the 1920s or 30s. The wooden material and metal roof of this structure sits in a pile at the T-shaped intersection of the Vannoy tract.

EXISTING CONDITIONS & PRESERVATION RECCOMENDATIONS – this material could be stored for potential reuse for other agricultural building repairs or replacements on site.

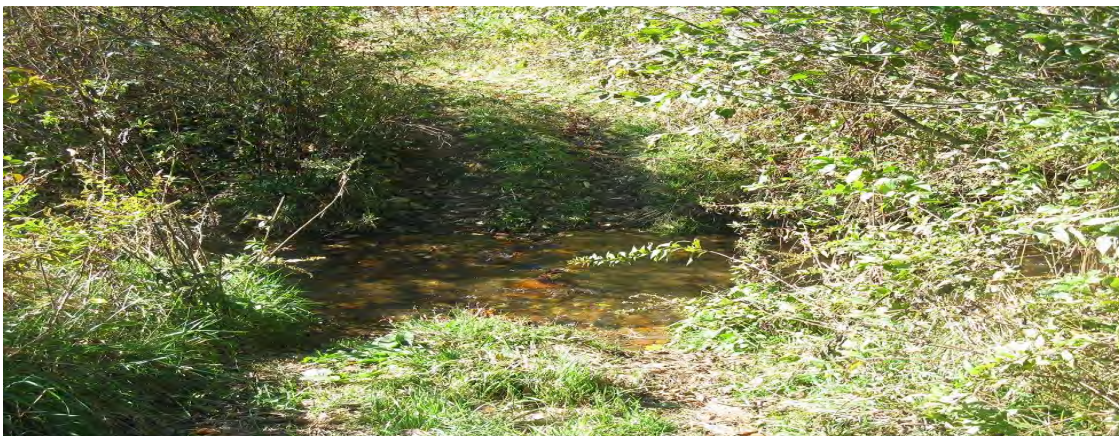
(iii) wood roads and logging roads – primarily dirt and gravel trails exist on the property; most date to logging operations from the 1940s to the 1960s. Those that were constructed for the most recent use as a Christmas tree farm likely were on the same paths of these previous road uses.

EXISTING CONDITIONS & PRESERVATION RECCOMENDATIONS – These roads are those within the boundaries of the property, they are not the local government maintained roads that outline portions of the property. These roads appear to be extensive throughout the property, and one existing roadway is a driveway to an adjacent property owner’s residence at the highest elevation on site. These wood roads and logging roads are considered cultural landscape features as part of the site’s history.

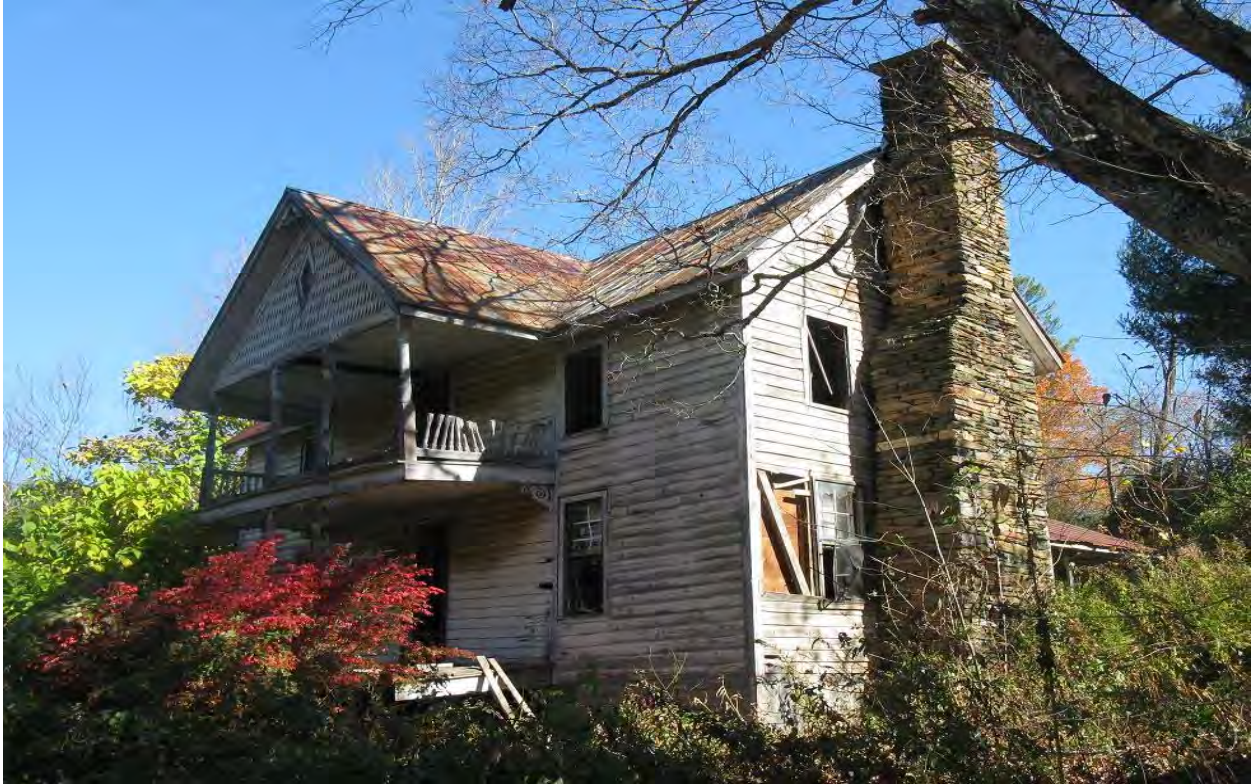
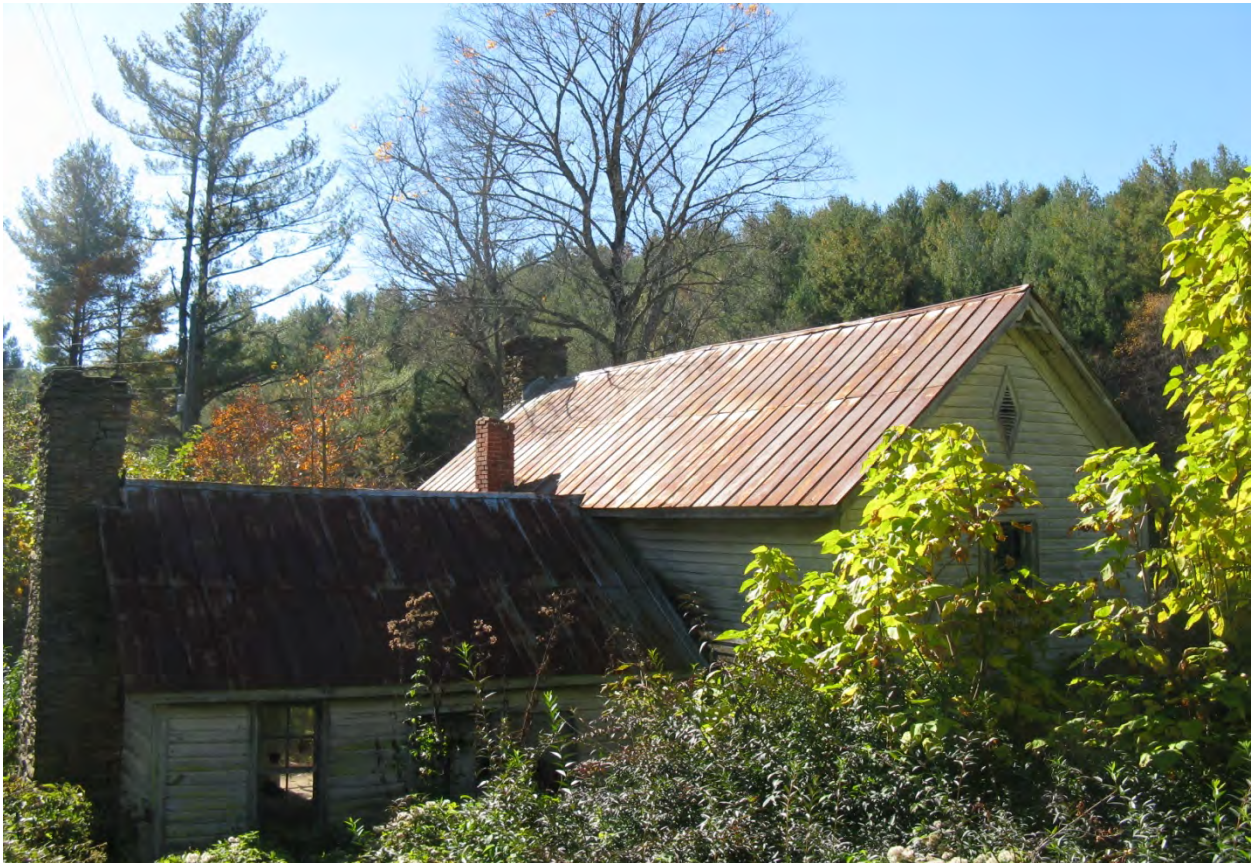
EXISTING CONDITIONS & PRESERVATION RECCOMENDATIONS – From the easement “The Vannoy house appears to date from 1890 to 1900. It is a typical small mountain farmhouse of the period, quite plain, with a small amount of Victorian gingerbread trim on the two-story porch. There has been some vandalism to the structure, though it is essentially intact. The most notable feature of the home place is the two remarkable dry-laid stone chimneys, which are in very good condition. The home place may be possible to renovate, although it is currently in disrepair.”

Since the easement was placed on the property in 2002, this vandalism and current condition of the property has worsened considerably. It seems likely that the building continues to be vandalized and potentially also recently partially lived in. Consulting with local law enforcement regarding frequency of incidents will give some indication as to the current and historic level of crime that has taken place in this structure. The extent of vandalism is severe and many architectural features have been removed from the property or are lying around the structure, the original door was in the ground near the entrance for example in October 2010, but is now gone a month later. The building’s foundation will also need the

services of a structural engineer to determine its current stability. It appears unlikely that the current foundation of wood piers and brick blocks can be maintained for future use of the structure which creates a crawl space that is nearly two feet in height and overly exposed to the elements, animal infestation, and pooling of water underneath the structure. A new foundation will likely be required, one that takes the building to ground level if feasible, but with leaving vents for air flow. A majority of windows on the property are open and animal infestation is also apparent. Unless an immediate future use of this property is determined, my suggestion would be to mothball the structure. The best guide for such a procedure is found in “Mothballing Historic Buildings” (National Park Service – Mothballing) and the opening summary information in this document is also found in (APPENDIX THREE). These actions should be taken after an estimated cost is given on foundation repair. It is possible that costs will be prohibitive to the rehabilitation and future use of this structure. Another strong concern would be whether random human occupancy continues in the property, in which case the chance of fire or other damage increases significantly. From a proposal to First Citizens Bank by Appalachian State University: “Stabilize, secure, and renovate the historic Vannoy farmhouse for use as space for agricultural programs and research that will be conducted on the 189 acre Vannoy farm property. Cost \$85,000.” The overall estimated cost for rehabilitation of this property is likely \$500,000 or more given its current condition and needs.

The two-level porch which is a distinctive feature of the property is also the most vulnerable. The second floor has a strong downward slant to it and it should be considered unsafe for more than a few people to stand here at any one time. Stabilization of this portion of the property may be achieved by adding temporary wooden piers. The decorative wood brackets and additional details should also be considered for removal, so that they can be used again on a future rehabilitation of the property. Original material may continue to be lost with continued vandalism.

The center-passage-plan interior features a stair with square newel post and balusters, plain board and beaded tongue-and-groove wall and ceiling finishes. The rooms have generally low height clearance on both floors. There are original wooden doors and door knobs throughout the interior. The exterior central rear ell of the building also has a dry stone laid chimney, as does the prominent eastern elevation. There is a central brick chimney without flashing through the building; and all chimneys appear in remarkable condition given the damage to other portions of the building. Future use will determine the level of preservation to use on interior spaces and features.

The roof has a rusted look on the exterior likely because it is of galvanized steel. From the 2<sup>nd</sup> floor porch you can view the roof interior and it shows it to be relatively new, maybe placed on the structure in the past twenty years. Likely there was a metal roof on the property before, placed in the 1940s, which replaced an original wood shingle roof, possibly chestnut shingles. There is access at this location and in other areas of the second floor to this smaller attic area and roof, though in its current condition the weight load may be very low and unsafe.

At this stage it may be premature to mention HVAC, plumbing, electrical, and ADA considerations for this property. All will likely be needed regardless of use and can create a significant fluctuation in project cost. If ultimately demolition is suggested for the building, I would strongly recommend utilizing the process of “deconstruction” engaging students, classes, or expertise from the Technology Department.

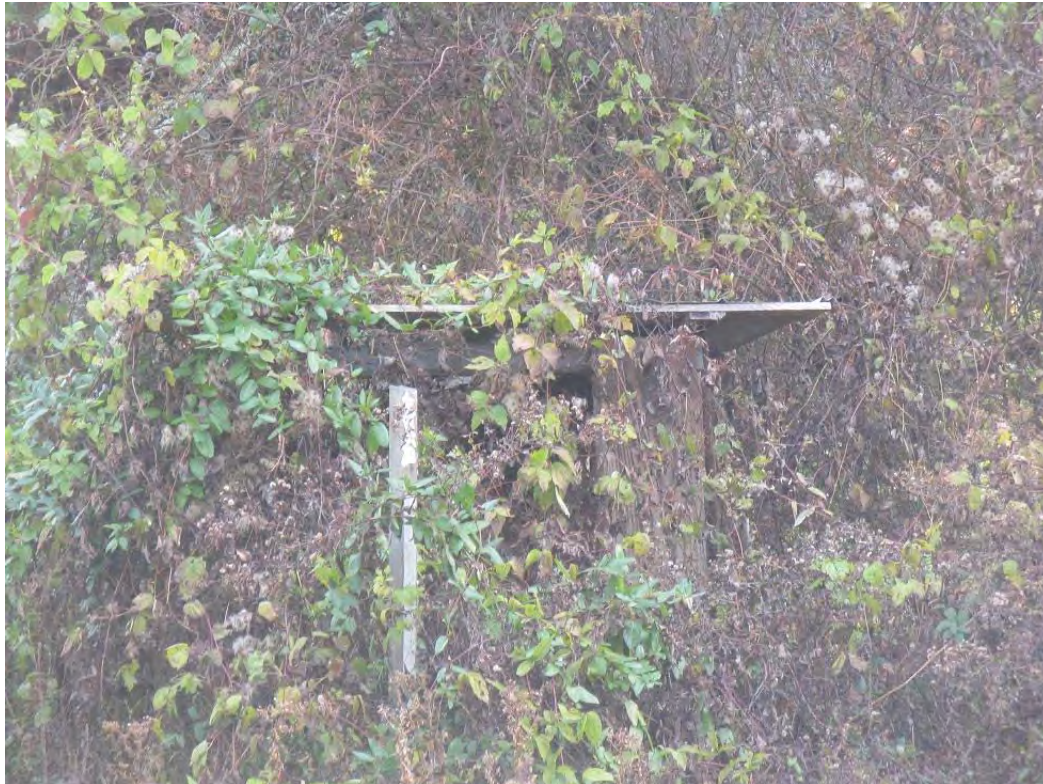
(vii) outhouse – likely a c. 1910s building roughly fifty feet north of the rear elevation of the Vannoy home place and entirely covered in vegetation.

EXISTING CONDITIONS & PRESERVATION RECCOMENDATIONS – access to this building is limited due to current vegetative growth and no logical pathways to its location. The structure itself is overwhelmingly covered with vegetative growth, but a shed roof and overall wood construction can be determined. A closer inspection of the property would be needed to determine if it remains structurally sound and could be used for storage or similar usage. A stream runs adjacent to this outhouse as it makes it way towards the larger portion of the New River.

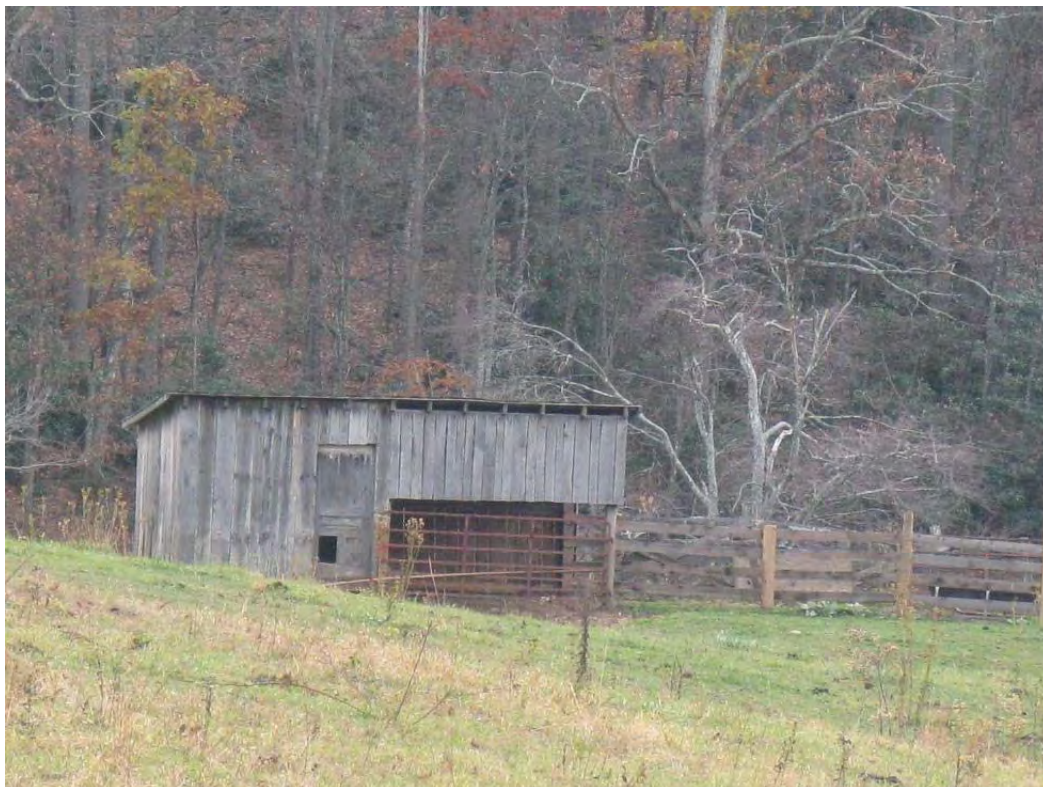
**EXISTING CONDITIONS & PRESERVATION RECCOMENDATIONS** - Since this area was in active agricultural and livestock grazing use with perimeter fencing, it was not possible to view the structure closely in detail. However, it appears to be an open barn/shed structure used for the storage of hay and additional animal feed. It is constructed of wood weatherboard with a wooden roof and wood eaves. It appears structurally sound and could continue to be used for its current function for feed storage by Appalachian State University.

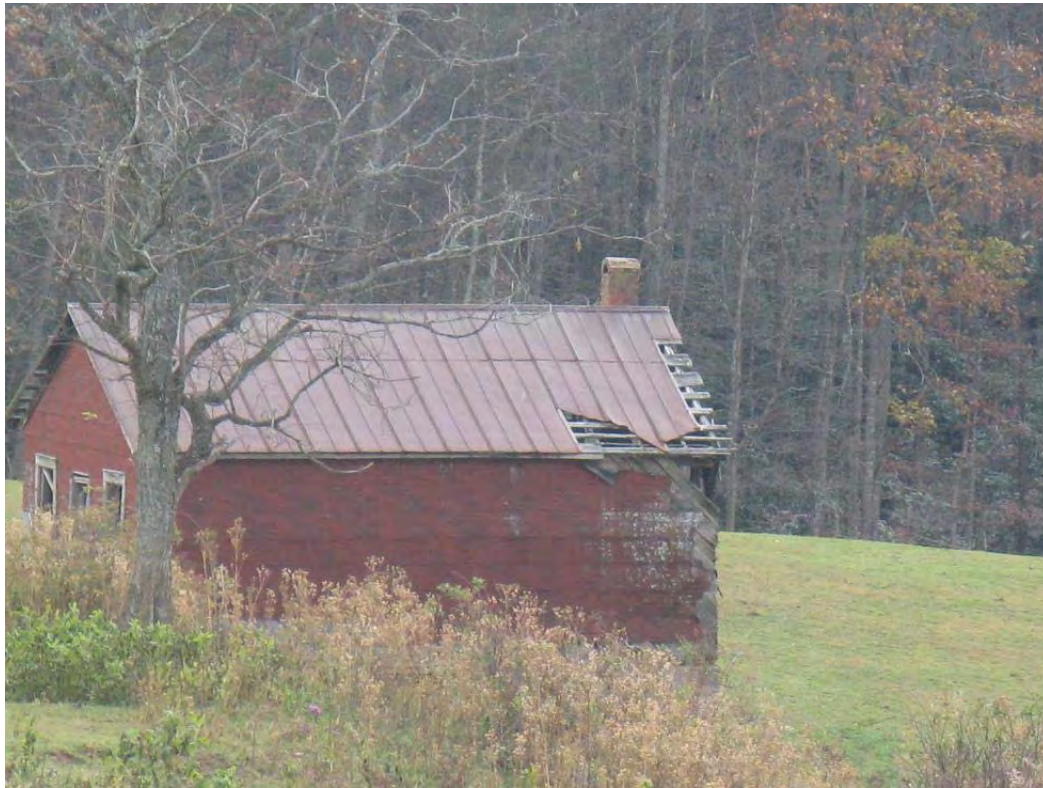
**EXISTING CONDITIONS & PRESERVATION RECCOMENDATIONS** - Since this area was in active agricultural and livestock grazing use with perimeter fencing it was not possible to view the structure closely in detail. It appears to be originally constructed of weatherboard with a current faux brick exterior, maybe concrete block construction, or a peel on asphalt strip treatment. There is a metal roof with portions blown off and one brick chimney. It appears that with a shoring up of the roof that this building could continue to serve for adequate storage, it is not recommended to be used as a residence.

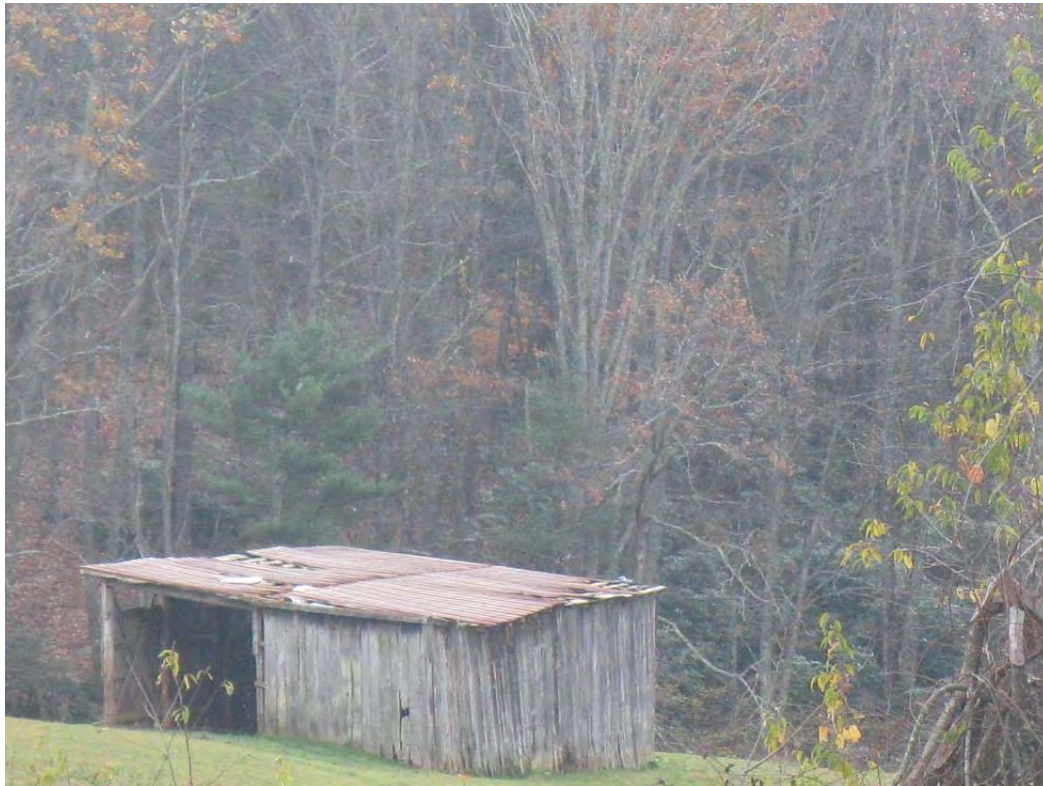
**EXISTING CONDITIONS & PRESERVATION RECCOMENDATIONS** - Since this area was in active agricultural and livestock grazing use with perimeter fencing it was not possible to view the structure closely in detail. However, it is a weatherboard constructed open bay shed building with a shed roof of metal attached to wood. Pieces of the roof appear to have blown off but it appears structurally sound, and could continue to be utilized for livestock and feed storage purposes.
